Navigating the Skies Safely: Building Resilience in Aviation Safety

Member Michael Graham

In-Flight Collision During Air Show Commemorative Air Force

Dallas, Texas
November 12, 2022

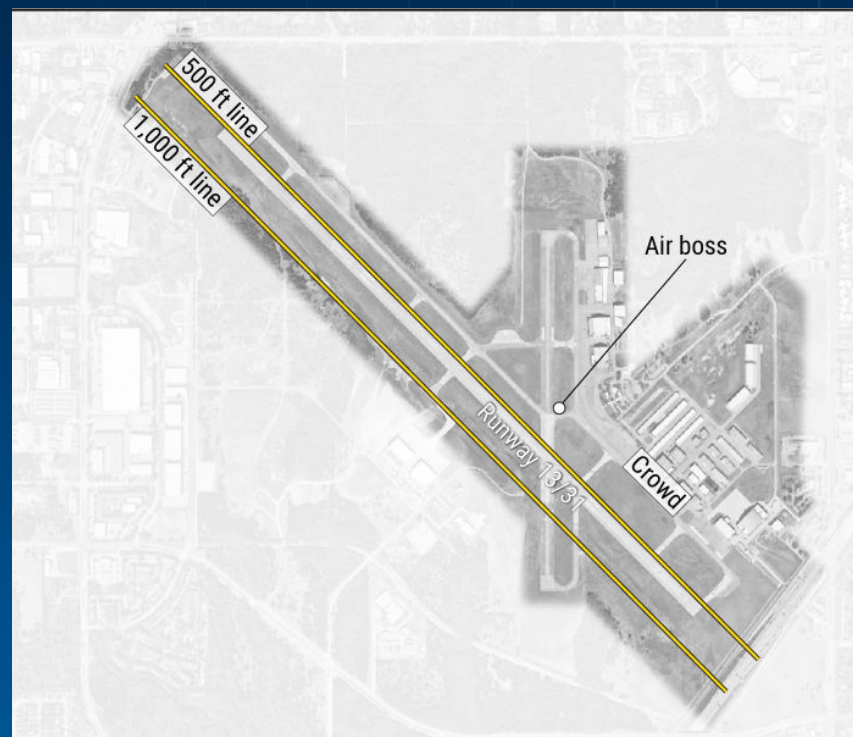
Runway, Show lines, Crowd, and Air Boss

Questions:

- What was briefed?
- Which aircraft was to be on which show line?
- What was the altitude separation?
- What were the Air Boss directives?

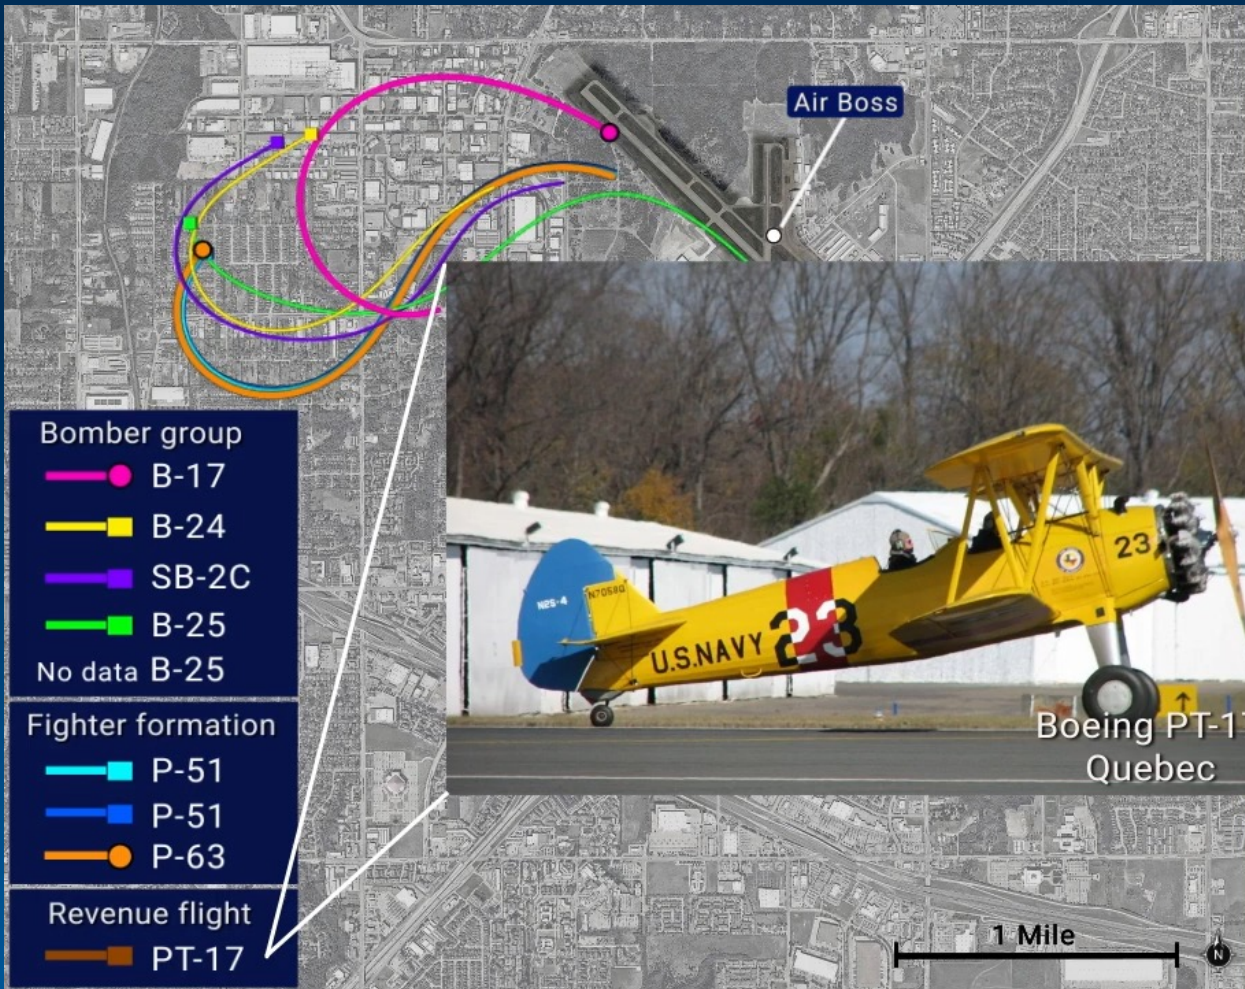
Air Boss communication

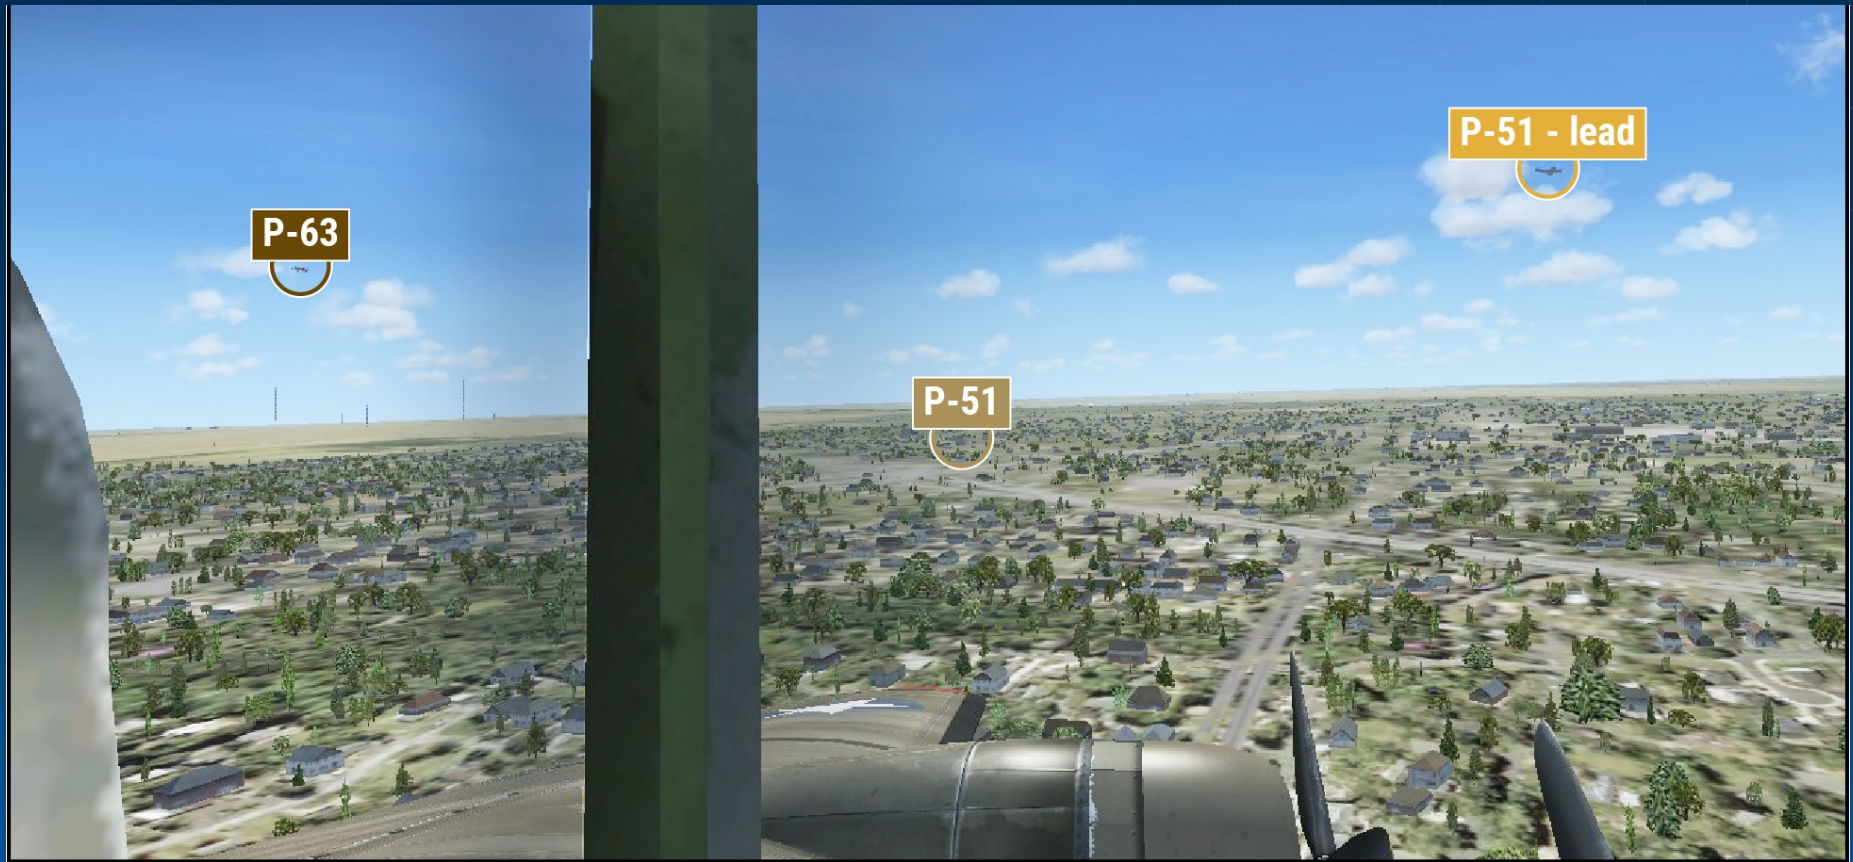
Visibility Simulation

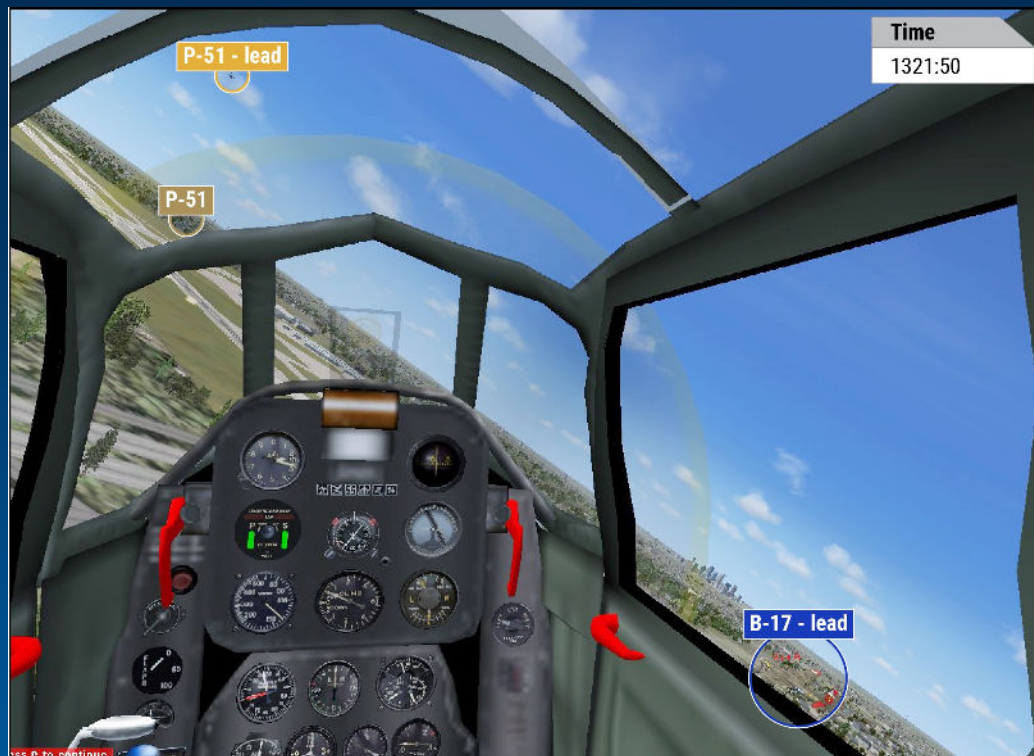
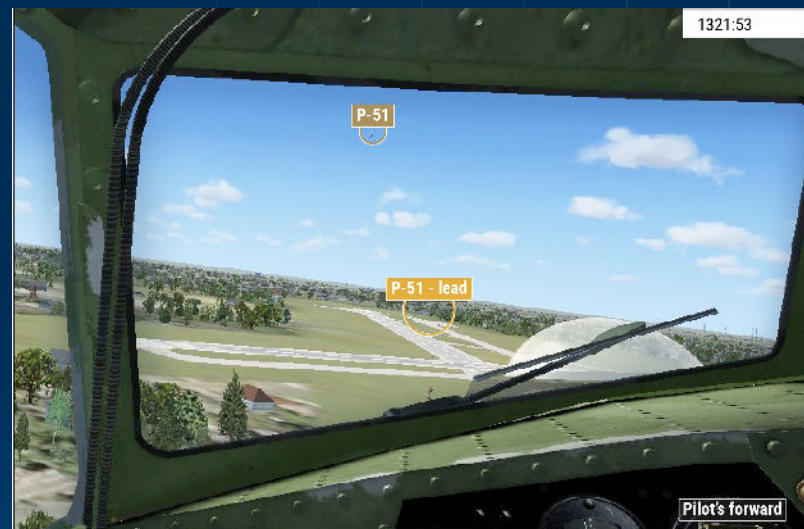
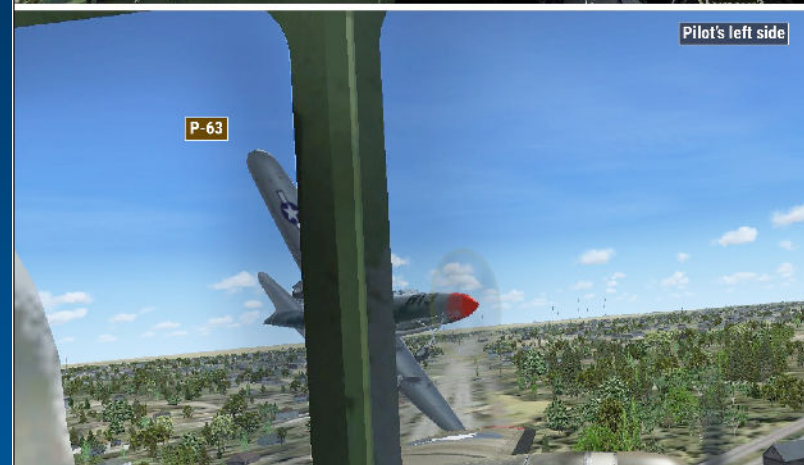
Visibility Simulation

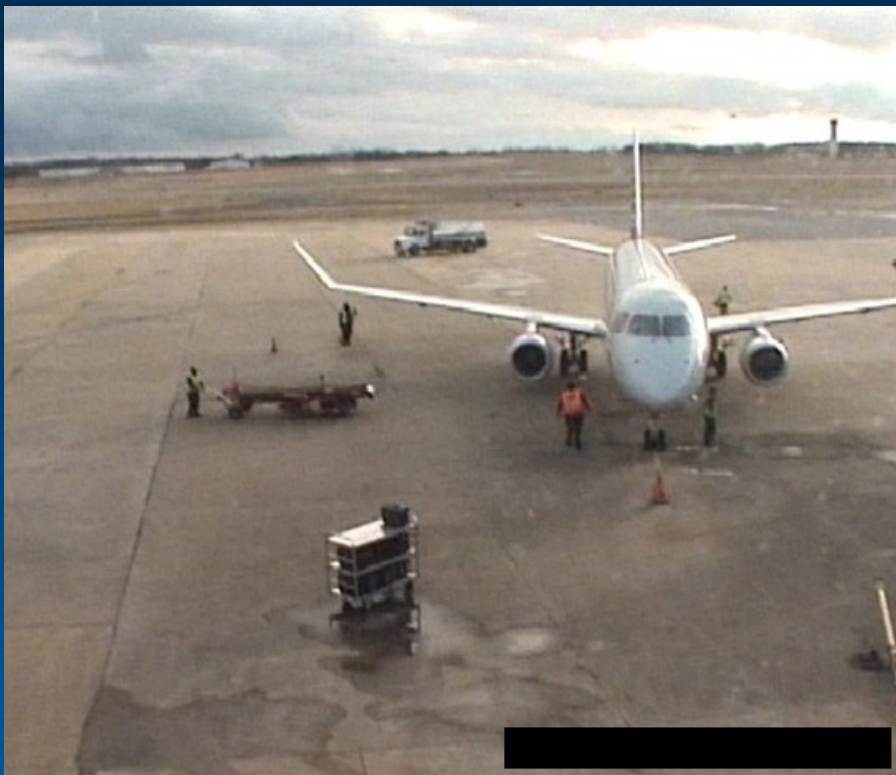
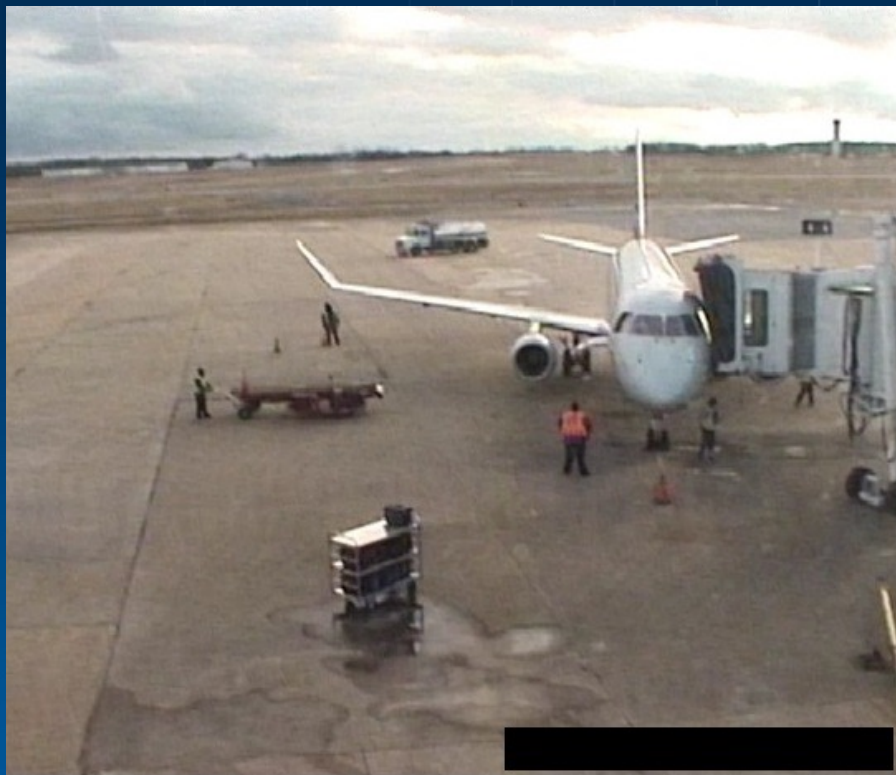
Accident Sequence

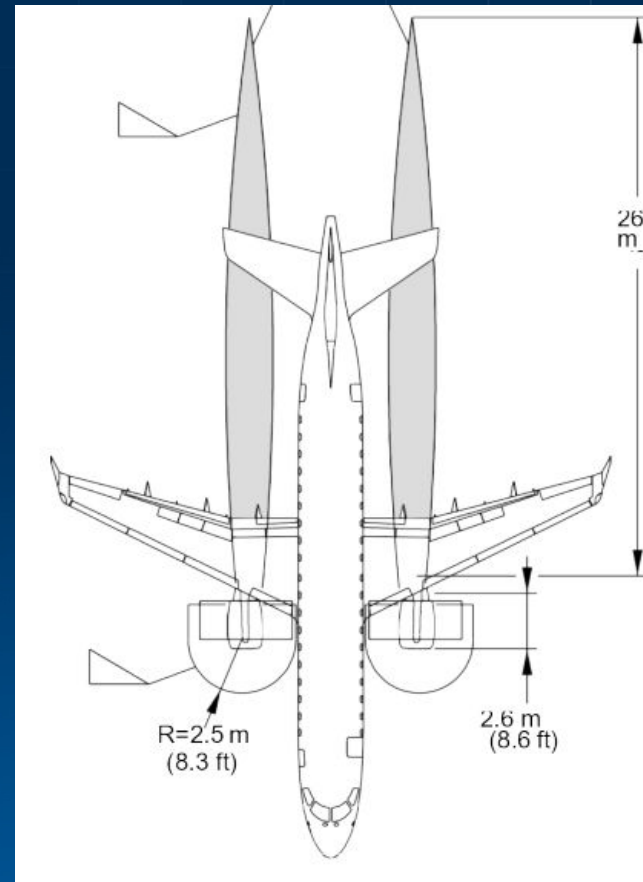
Inlet and exhaust hazard area (E 175 Airport Planning Manual)

- Jet engines spin with powerful speed and are extremely dangerous until spooled down. The area in front of the engine is called the ingestion zone. The ingestion zone for all aircraft types is 15 feet. You must never enter the ingestion zone until the engine has spooled down
- The jetblast zone at American Airlines and American Eagle is 100 feet for each aircraft when the engines are at idle speed

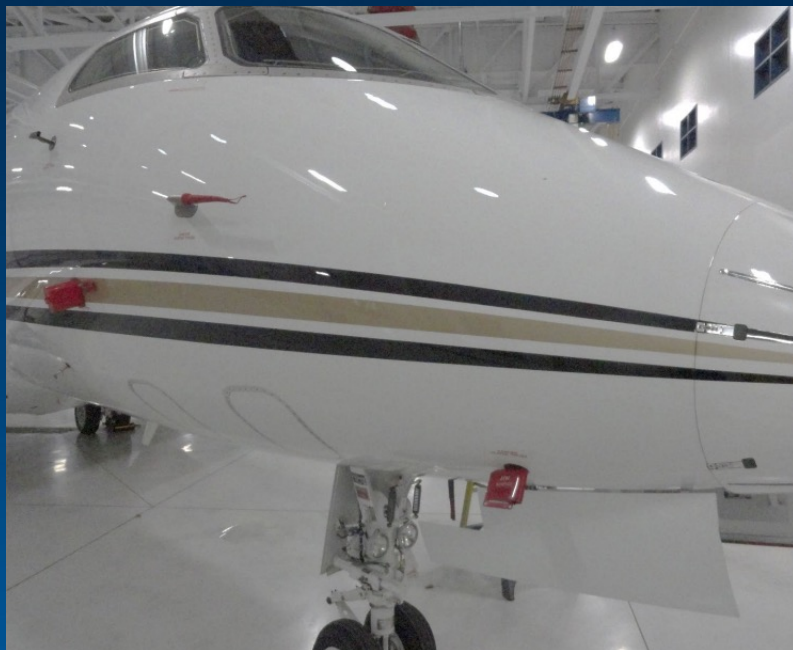
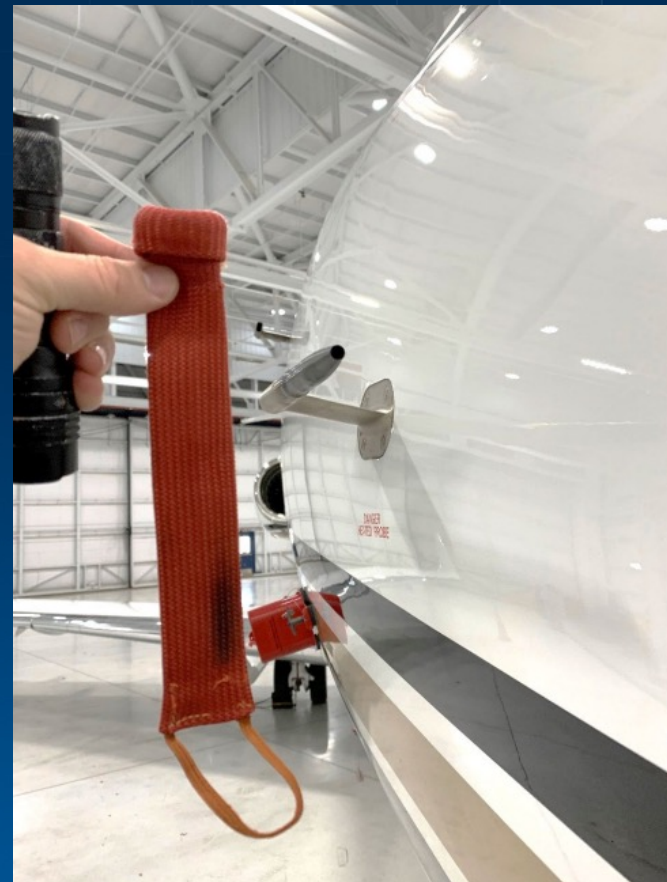
Preflight Interruption

- CAS cyan advisory “RUDDER LIMITER FAULT” message
 - Two avionics stall tests (STALL/RUD LIM test) to clear
- Fault message discussion
 - Call maintenance, No - “it’s advisory only”
- No FD command bars on attitude pitch indicator
 - Elected to continue takeoff
- No V-speed bugs displayed

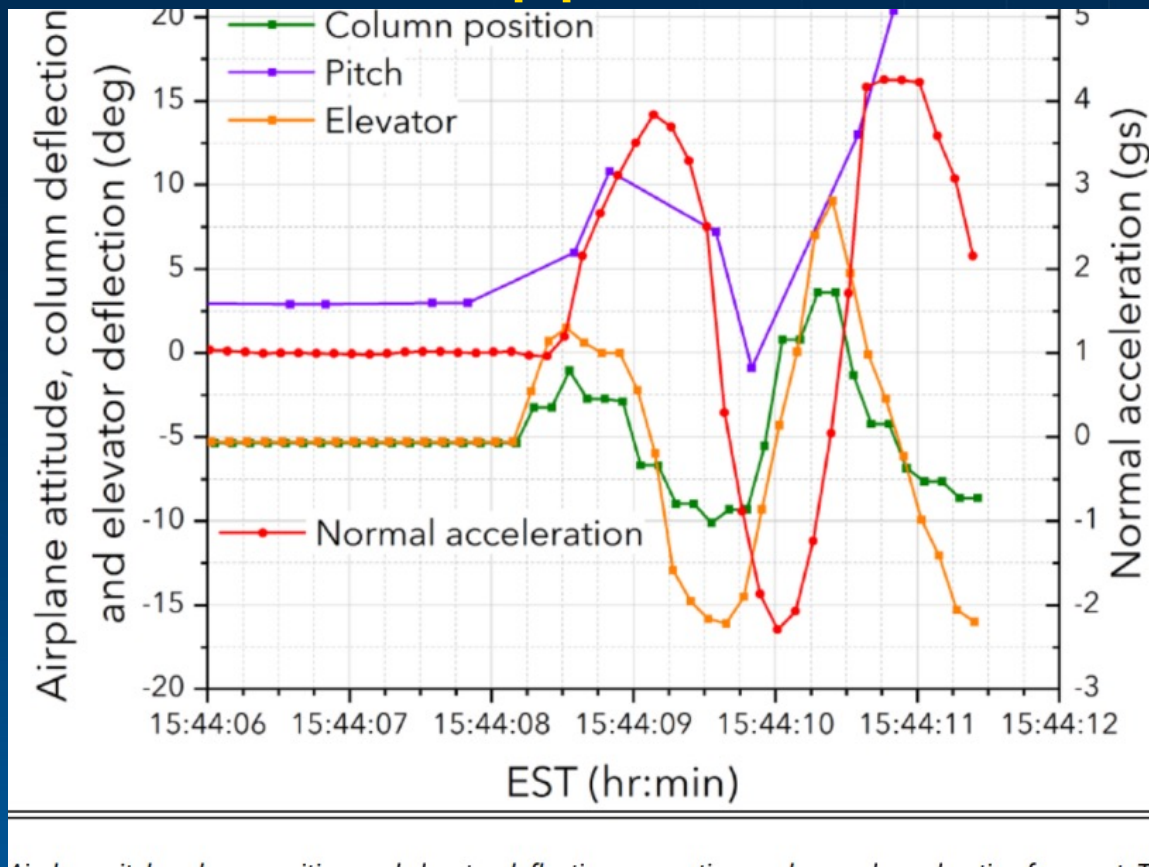
Airplane pitch, column position, and elevator deflection versus time and normal acceleration for event. The dots on each trace show each sample of the FDR channel.

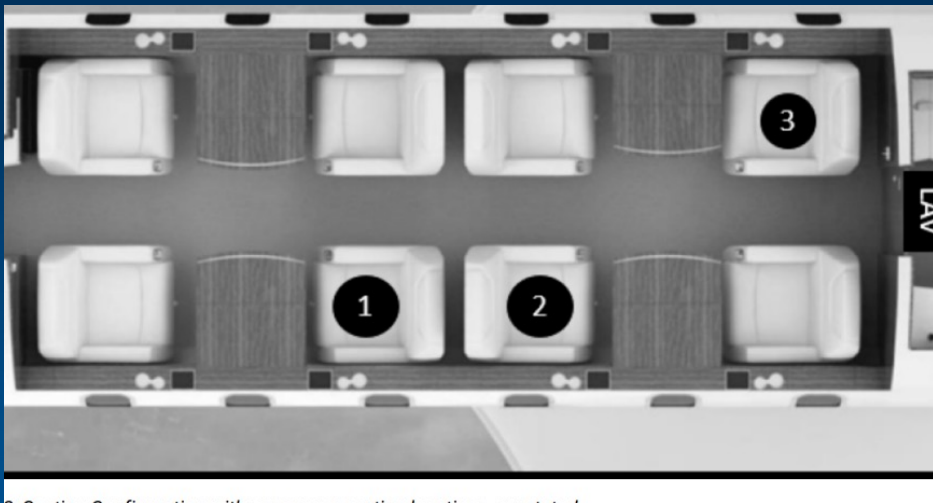
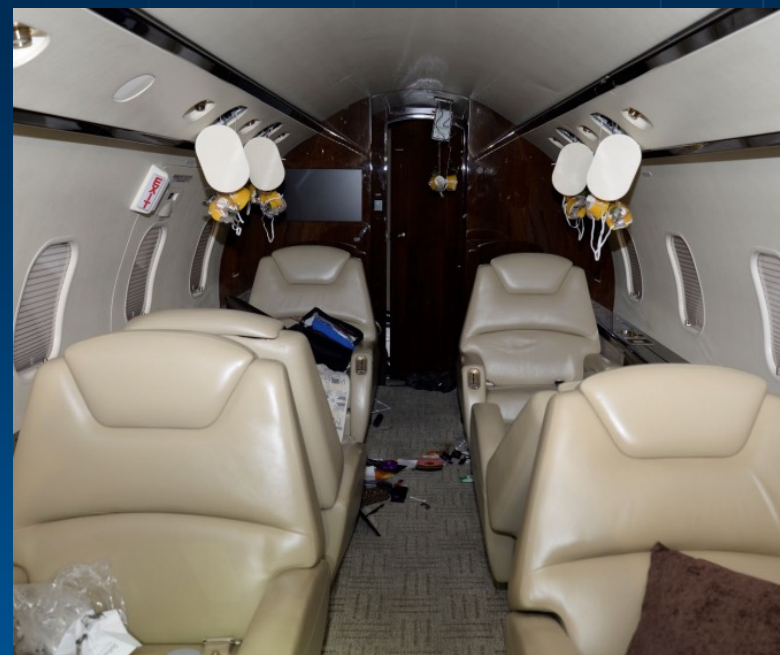
Cabin Damage

(Photograph Courtesy Federal Bureau of Investigations)

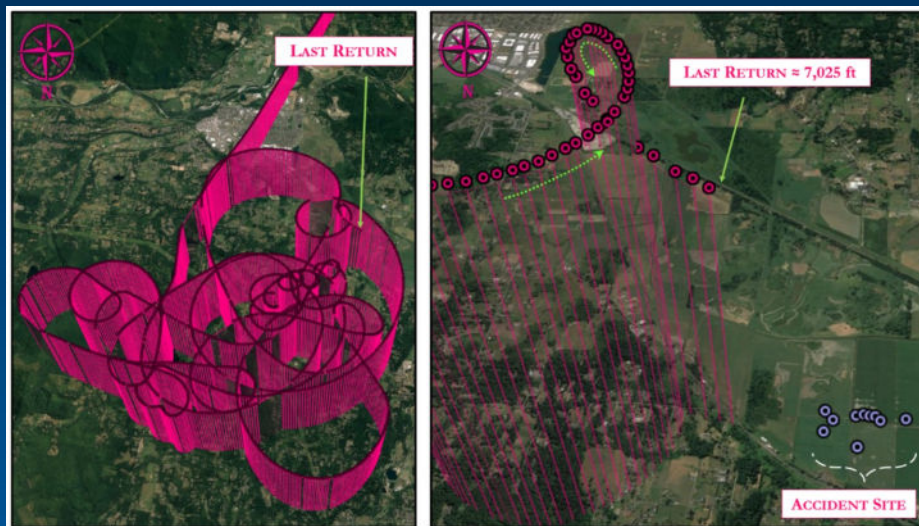
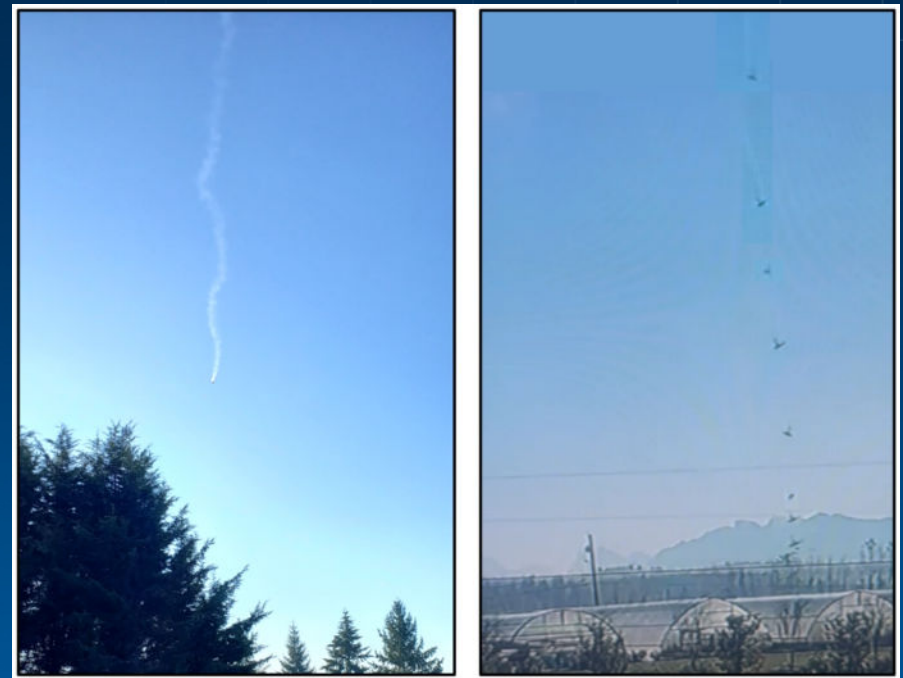
Inflight Breakup

- Peak airspeed 223 KIAS
 - 98 KIAS above V_{fe} & 48 KIAS above V_{mo}

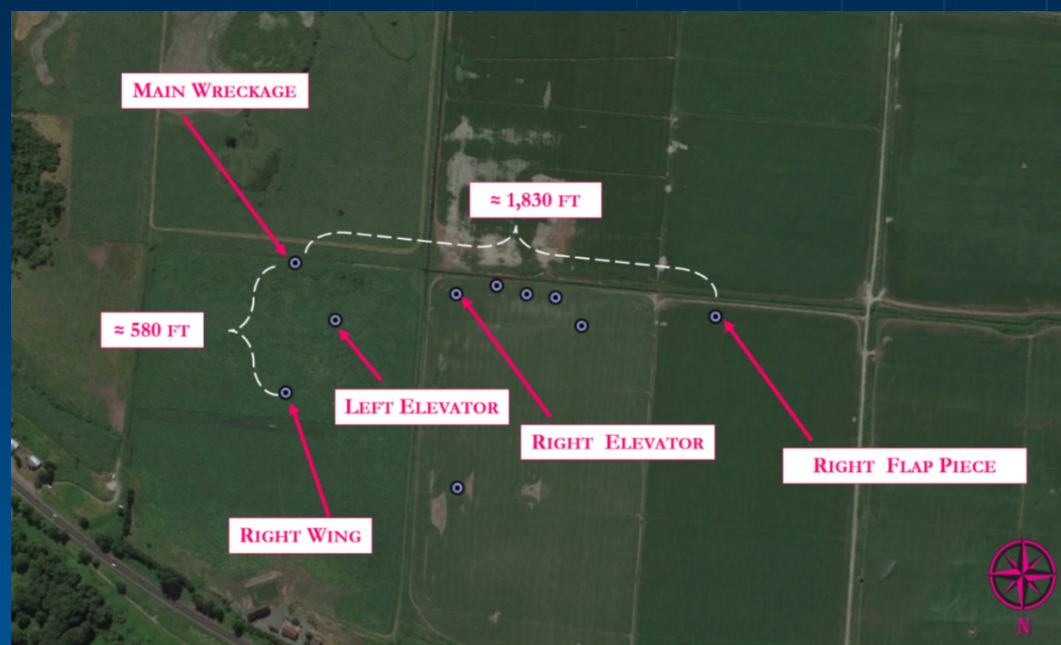
Inflight Breakup

- Right wing and strut separated
- Right flap was separated into numerous pieces and scattered
- Left wing separated from fuselage on ground impact
 - Flap attached and retracted

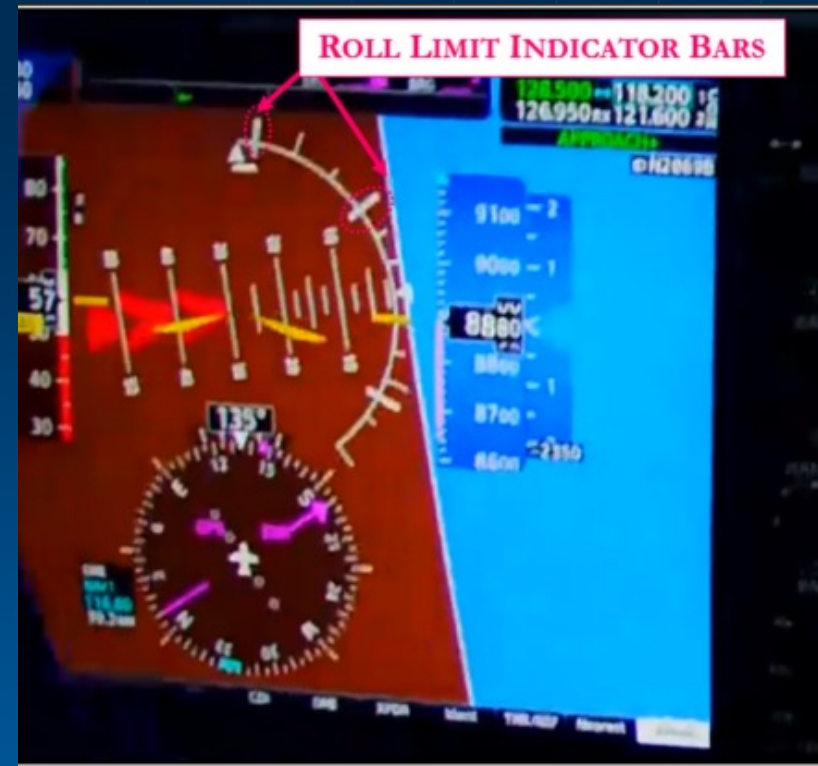
Test Flight 07 Exceedances

- 30 degrees left bank, flaps extended, idle power, “unaccelerated” stall
- “pass” if bank angle does not exceed 60 degrees in direction of turn or 30 degrees in direction opposite the turn
- Aircraft exceeded allowable roll limit and exceeded Vmo
 - 83 degrees and 183 KIAS
 - Req. inspection and documentation
