Navigating the Skies Safely: Building Resilience in Aviation Safety

Member Michael Graham

In-Flight Collision During Air Show Commemorative Air Force

Dallas, Texas
November 12, 2022

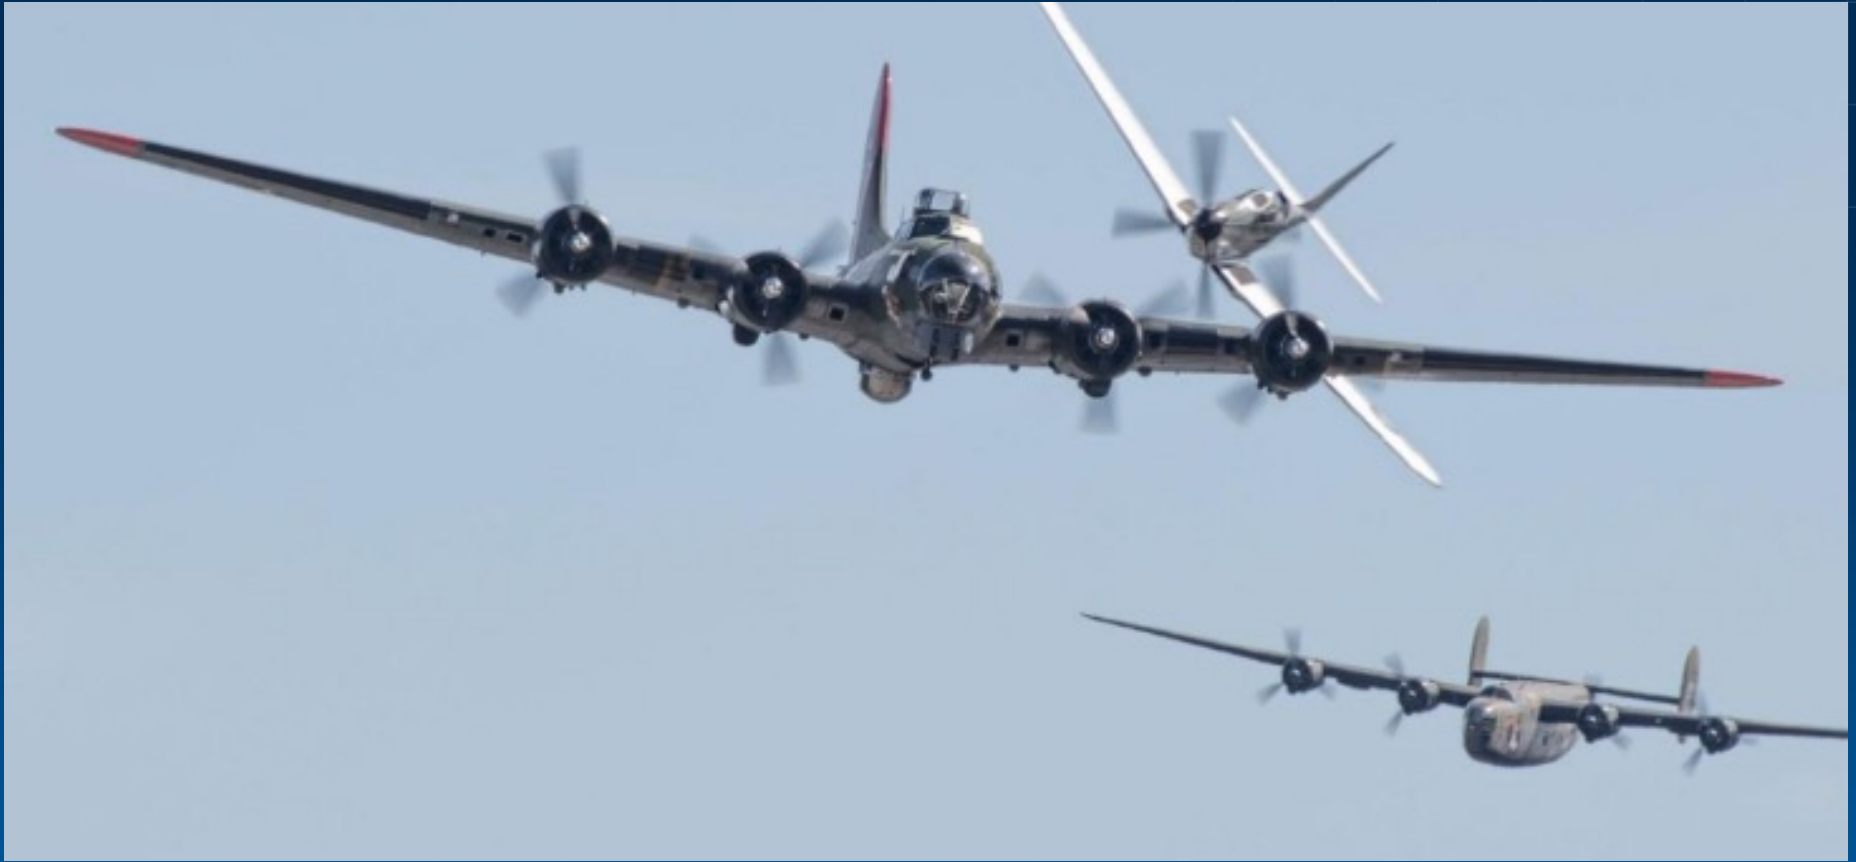
Probable Cause

- Air boss's and organizer's lack of an adequate, prebriefed aircraft separation plan for the air show performance
- Relying instead on the air boss's real-time deconfliction directives and the see-and-avoid strategy for collision avoidance, which allowed for the loss of separation
- Diminished ability of the accident pilots to see and avoid the other aircraft due to flight path geometry
- Out-the-window view obscuration by aircraft structures
- Attention demands associated with the air show performance, and the inherent limitations of human performance that can make it difficult to see another aircraft

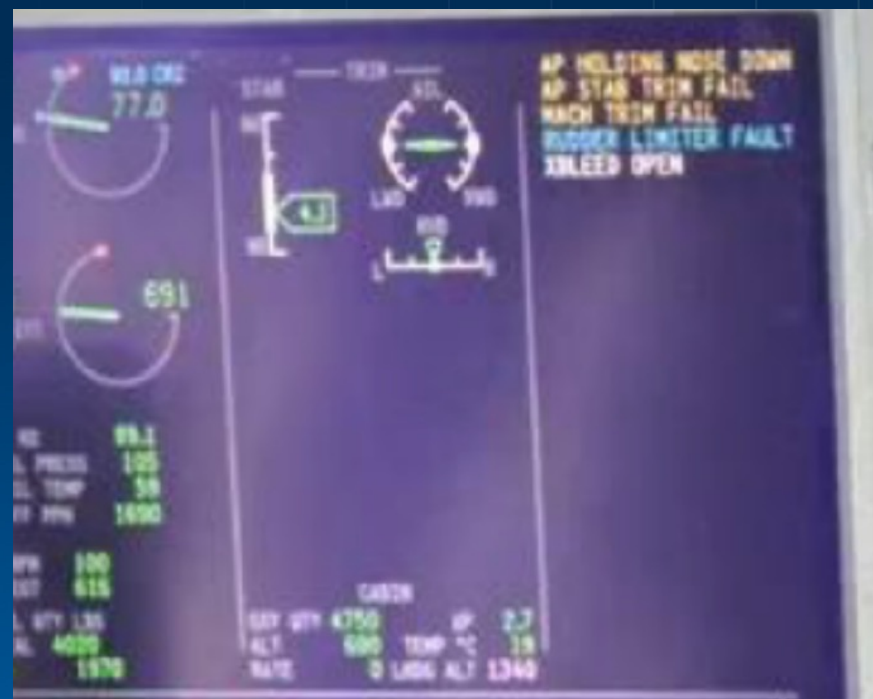
Challenger 300, N300ER In-flight Upset

The flight crew's failure to remove the right side pitot probe cover before flight, their decision to depart with a No-Go advisory message following an aborted takeoff, and their selection of the incorrect non-normal checklist in flight, which resulted in an in-flight upset that exceeded the maneuvering load factor limitations of the airplane and resulted in fatal injuries to a passenger whose seatbelt was not fastened. Contributing to the severity of the in-flight upset were the pilot-in-command's (PIC) decision to continue the climb and use the autopilot while troubleshooting the non-normal situation, and the PIC's pilot-induced oscillations following the autopilot disconnecting from the out-of-trim condition. Also contributing to the accident was the crew's inadequate crew resource management.
